Dakar COA

Level 2 Reserve Study

Type of Study	Update w/Site Visit
Date of Property Inspection	5/27/2022
Prepared By	Dale Gifford
Analysis Method	Cash Flow
Funding Goal	Full Funding

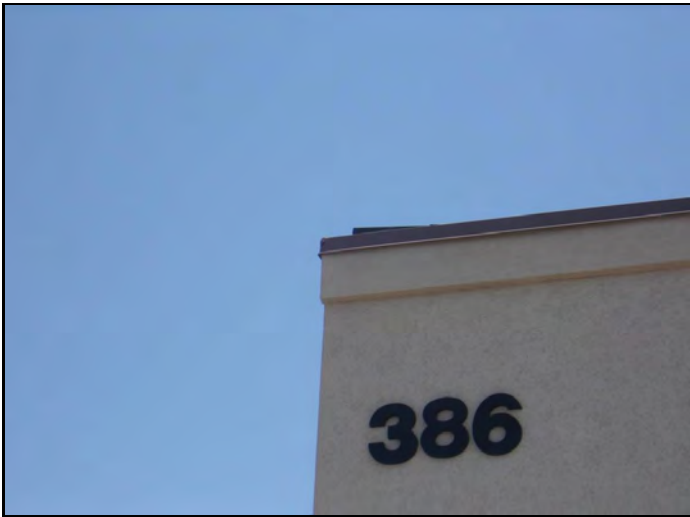
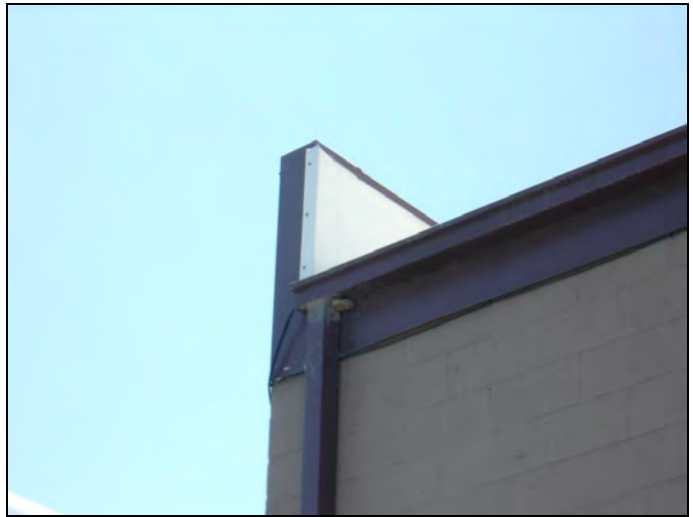
Comp #: 104 Flat Roof - Replace

Location: **Building Roof**

Research with the client reveals this component was replaced in 2019. We recommend funding to replace this component approximately every 20 - 25 years. Remaining life based on current age.

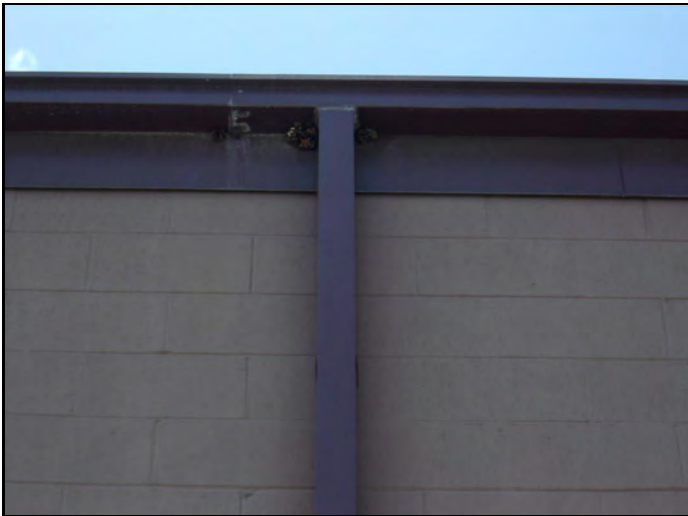
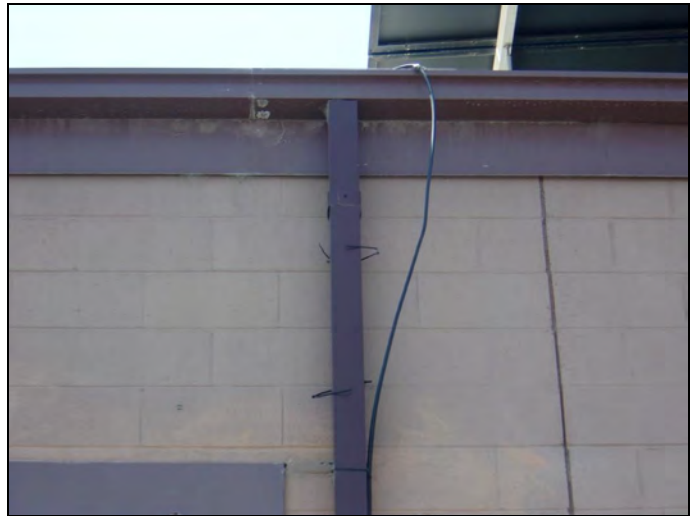
Comp #: 120 Rain Gutters/Downspouts - Replace

Location: **Building Rear**

The rain gutters and downspouts are in good condition. We recommend funding to replace this component approximately every 25 - 30 years. Remaining life based on current age.

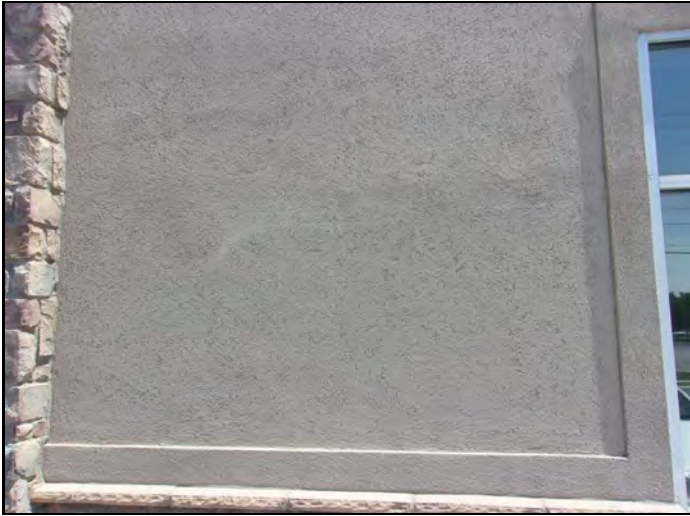
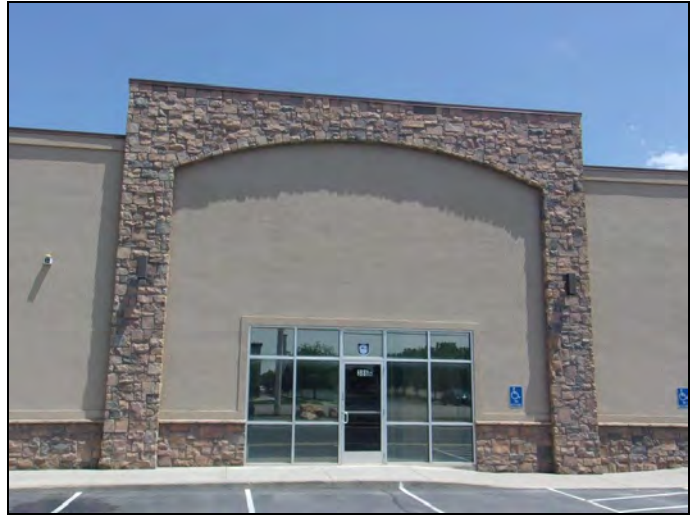
Comp #: 201 Stucco Surfaces - Repair/Repaint

Location: **Building Front**

The stucco surfaces are in good condition. We recommend funding to repair/repaint this component approximately every 12 - 15 years. Remaining life based on current age.

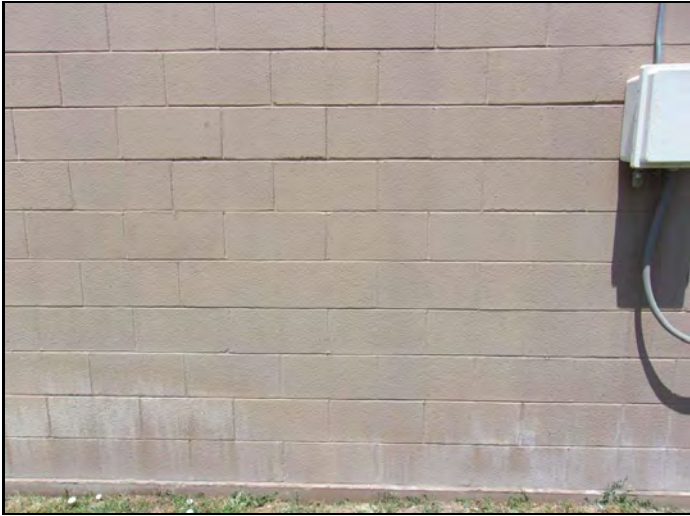
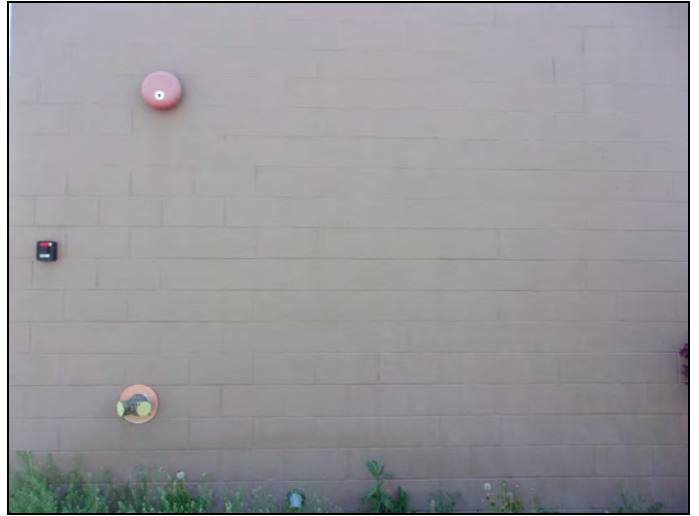
Comp #: 208 Block Walls - Repaint

Location: **Building Exterior**

The painted block wall surfaces are in fair condition. We recommend funding to repaint this component approximately every 10 - 15 years. Remaining life based on current age and condition.

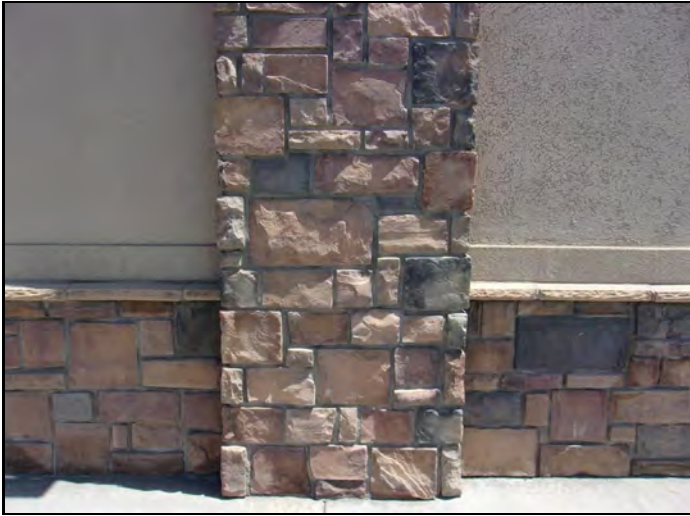
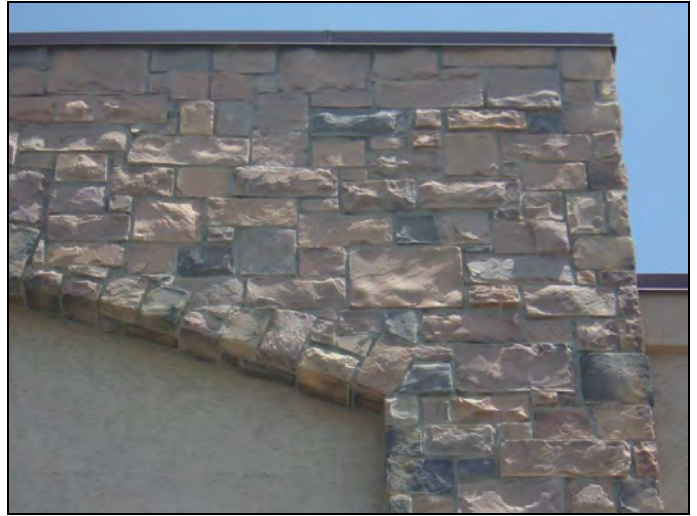
Comp #: 390 Faux Stone Siding - Replace

Location: **Building Front**

This component has an extended useful life. We recommend making local repairs as necessary as an operating expense. No reserve funding necessary.

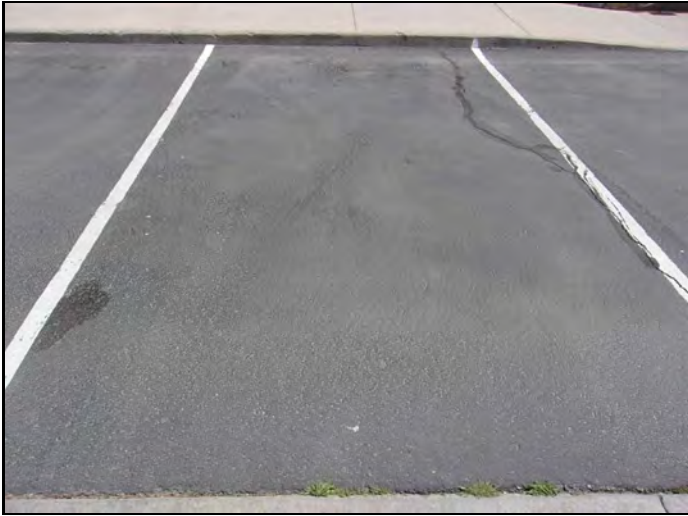
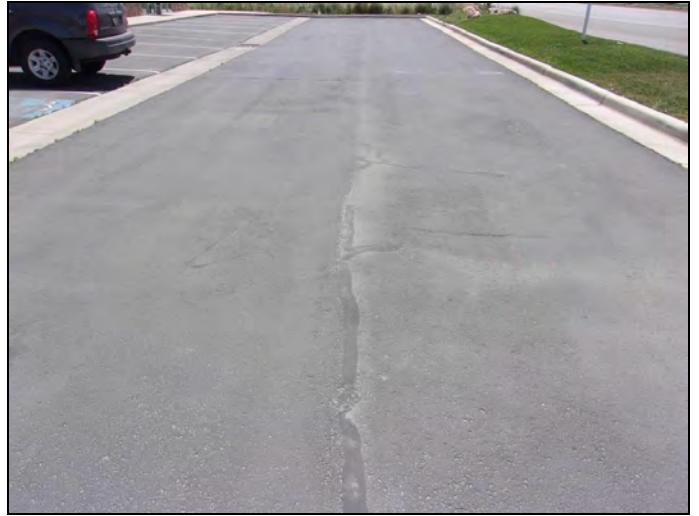
Comp #: 401 Asphalt - Major Rehab

Location: **Community Streets**

The asphalt surfaces are in good to fair condition. We recommend funding for a major rehab of this component approximately every 25 - 30 years. Remaining life based on current age.

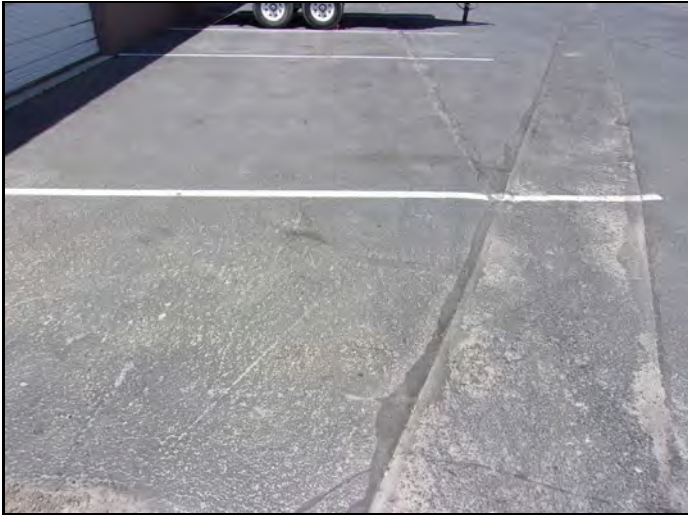
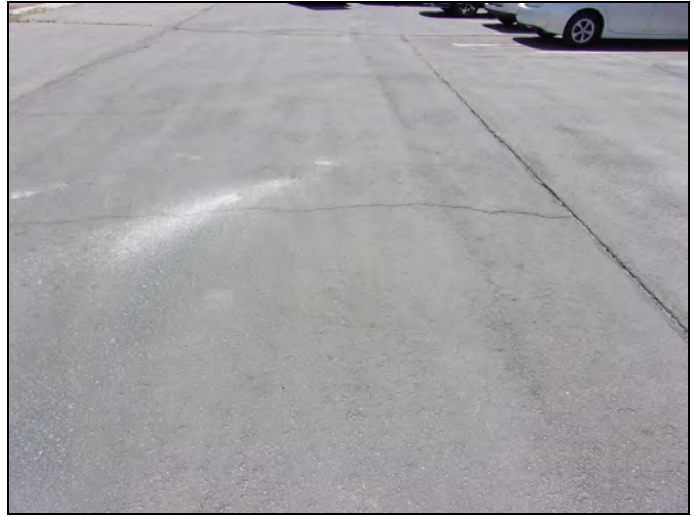
Comp #: 402 Asphalt - Seal Coat

Location: **Community Streets**

The asphalt seal coat is in fair condition. We recommend funding to seal this component approximately every 3 - 5 years. Remaining life based on current age.

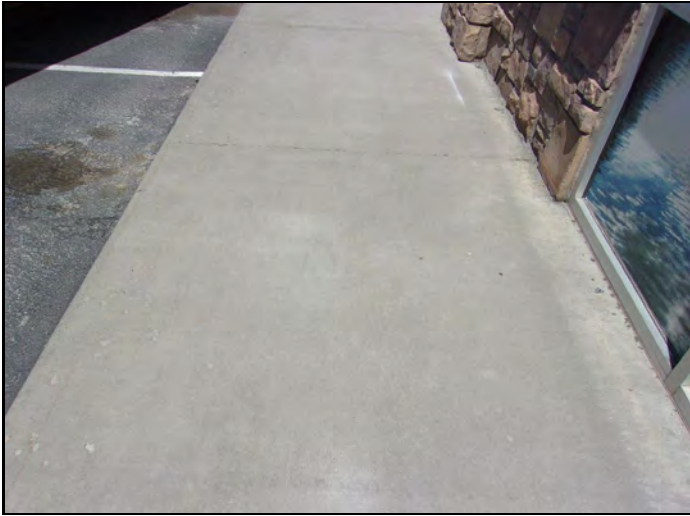
Comp #: 403 Concrete - Repair/Replace

Location: **Curb, Drain Swale & Sidewalk**

Due to the extended useful life of this component, reserve funding is not appropriate. Repair and replace as necessary as an operating expense. No reserve funding necessary.

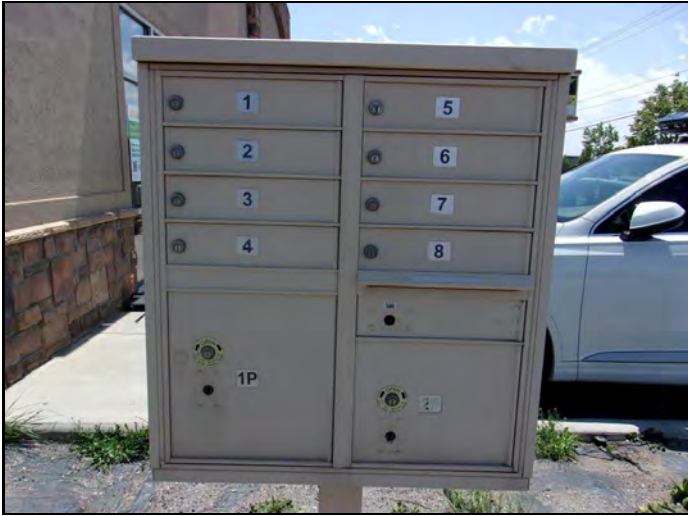
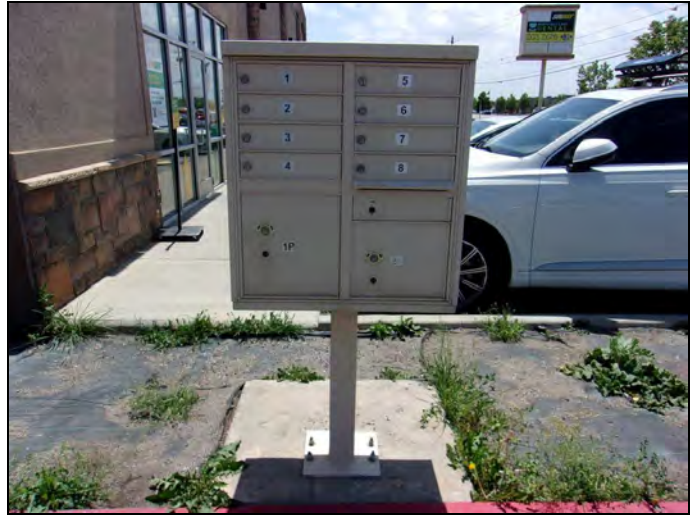
Comp #: 803 Mailboxes - Replace

Location: **Common Area**

The mailboxes are in good condition. We recommend funding to replace this component approximately every 20 - 25 years. Remaining life based on current age.

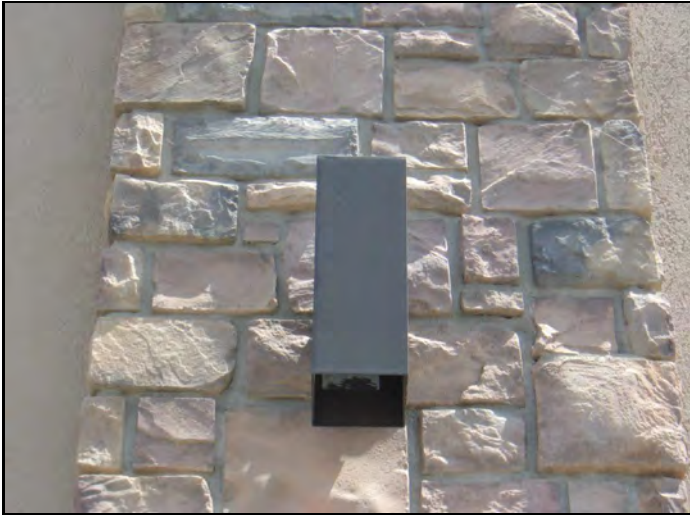
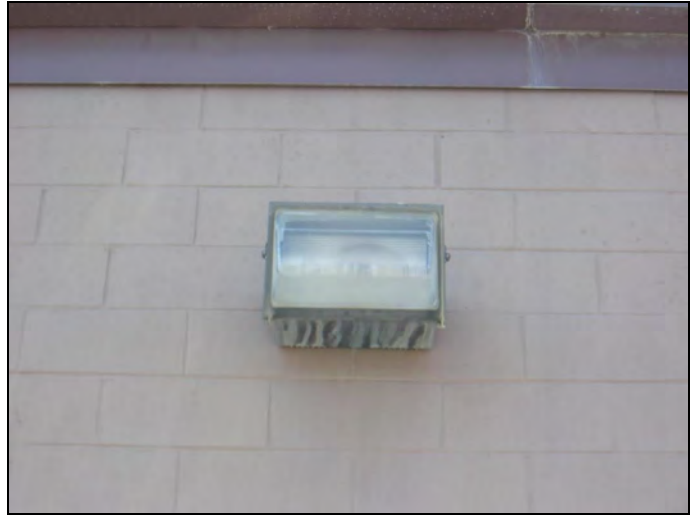
Comp #: 1602 Exterior Light Fixtures - Replace

Location: **Building Exterior**

The exterior light fixtures are in good condition. We recommend funding to replace this component approximately every 16 - 20 years. Remaining life based on current age.

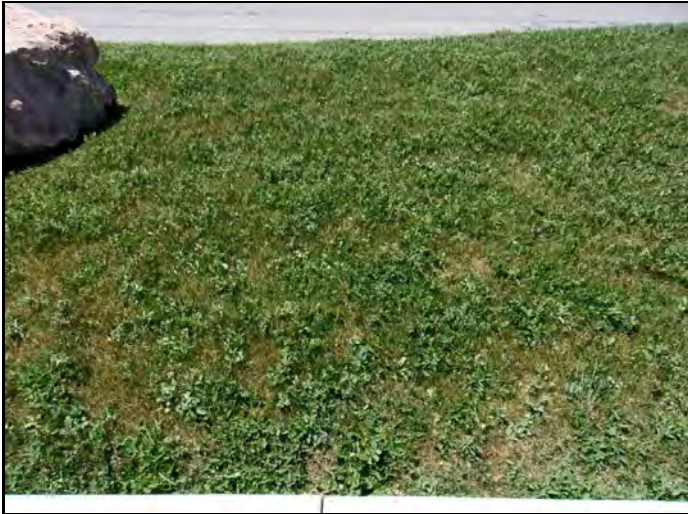
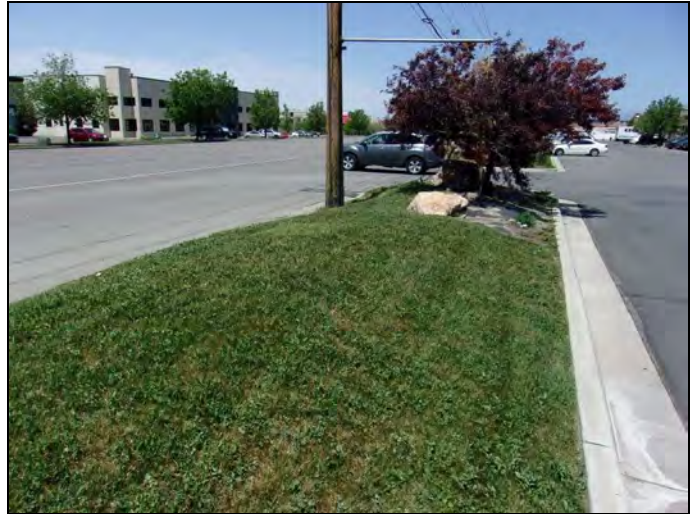
Comp #: 1812 Landscaping & Irrigation System - Renovate

Location: **Common Area**

The landscaping and irrigation system are in fair condition. We recommend funding for an allowance to renovate this component approximately every 20 years. Remaining life based on current age.
